## Australian Off Road - Series IV Systems Manual – Black Water System

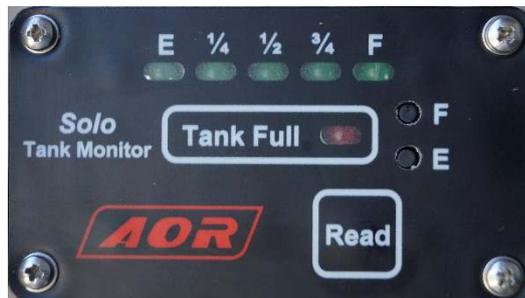
6. **Black Tank Gauge.** The Black Tank Gauge is located with other control items in the panel next to the door. The gauge is protected primarily by a 3 Amp blade fuse located in the 12 blade fuse block.

**Note:** If your van's Power Control Panel is a "Connex 6 Way Fused & Backlit Switch Panel" refer also to the "Note" at paragraph 5 above.

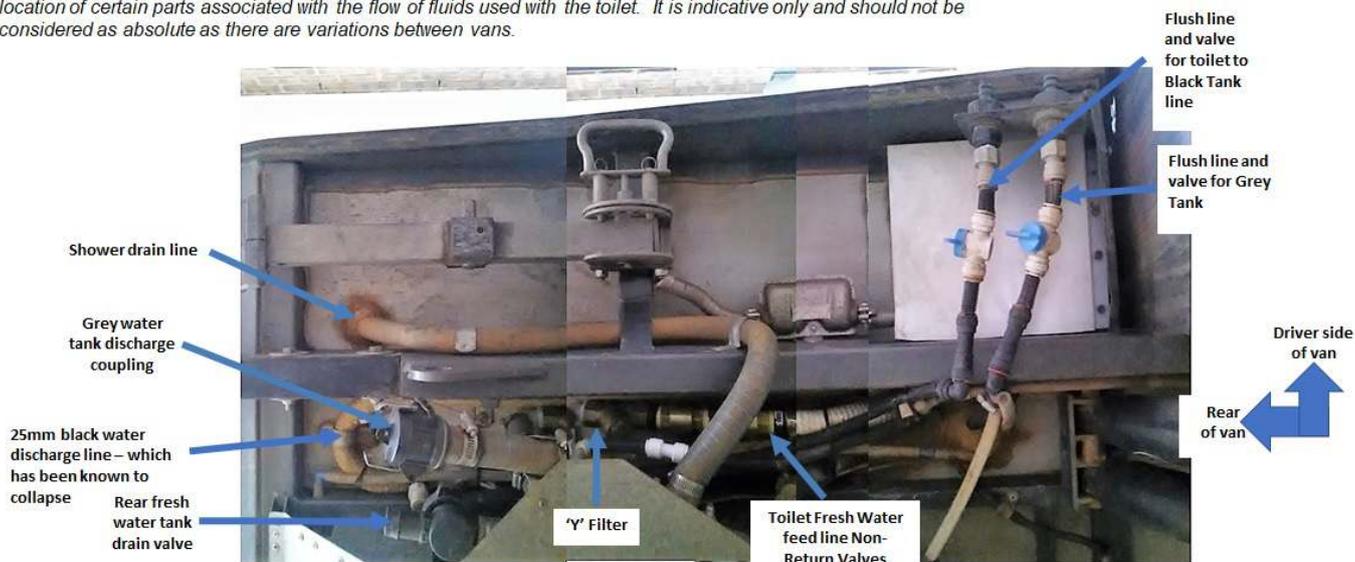
- a. **Vans without the shower recycle tank:** In the fresh water supply line for the toilet there are 2 brass non return valves. These are fitted to ensure there is always water in the feed line to the toilet's macerator pump. A 'Y' filter has been added to the line to ensure swarf from the water tanks does not interfere with the correct function of the two non return valves. The 'Y' strainer is a 2018 modification by AOR and if not installed on your van may be available as an upgrade from AOR or its authorised representatives. The photograph below identifies the general location of these valves and other related fittings.

**Note:** This photograph is from a late 2015 Series 4 Q Plus and has been included to aid in the identification and location of certain parts associated with the flow of fluids used with the toilet. It is indicative only and should not be considered as absolute as there are variations between vans.

- a. the driver's side of the van behind the wheel arch (to flush the black line between the TMC Toilet and the Black Tank). This flush point is identified in the photograph at paragraph 9.a above;
- b. at the front of the van behind the stone guard on the driver's side (to aid in flushing the visual gauge line; vent line, and Black Tank), and

- Some mid 2017 models have a 25mm discharge hose that kinks when bent around a sharp radius which then stops the toilet from being emptied. A repair kit is available from AOR. This section of pipe is identified in the photograph at paragraph 9.a above.

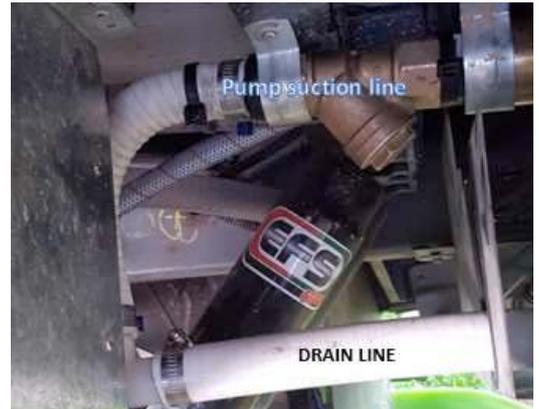
The toilet in these vans draw water from a dedicated 20 Lt tank that collects the shower runoff. This tank is located under the floor of the van forward or the rear water tank (i.e.: near the axle line). The flush water feed line runs from this tank through a 'Y' strainer and a brass non return valve before being attached to the water feed line of the TMC toilet macerator pump. The non return valve and the 'Y' filter are located below the floor behind the driver side wheel. The photograph to the right shows the typical location of the non return valve and the 'Y' strainer.

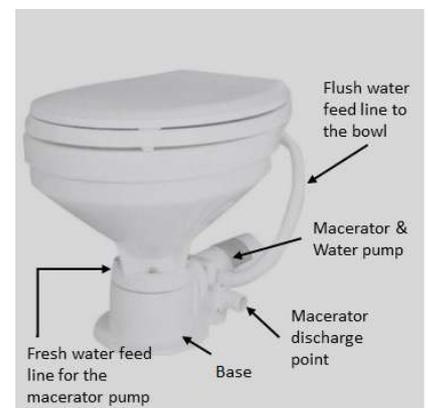
10. **TMC Toilet.** The toilet has a:

- bowl & lid;
- macerator which incorporates the flush water pump and motor;
- macerator base;
- fresh water feed hose;
- waste fluid discharge hose, and
- flush water (pump to bowl) hose.

11. Whilst the repair process is discussed separately, if the macerator fails, AOR recommends that the complete macerator & base unit be changed out as one piece.

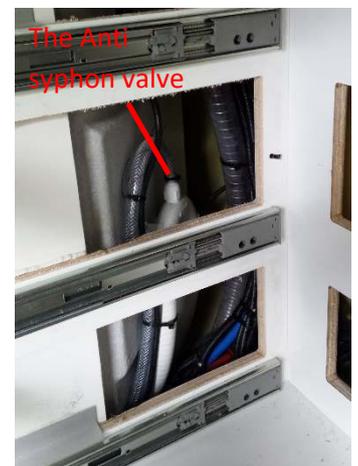
13. The anti-syphon valve is installed at the rear of the shower cubical and is accessible by removing the drawers from the rear vanity/kitchen unit. The photograph to the right shows the general location of the inverted 'U' bend and the anti-syphon valve.

14. The valve (a 'Joker' or 'Duckbill') is accessed by undoing the cap and then carefully removing the rubber valve.

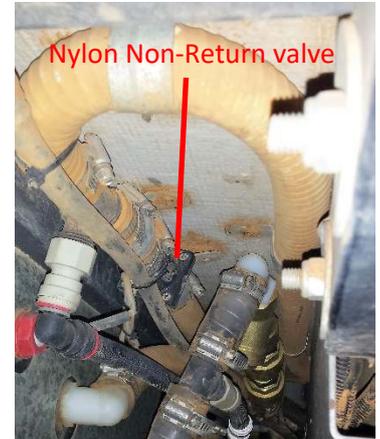
16. **Nylon Bodied In-Line Non Return Valves.** There are also a number of Nylon bodied non return valves fitted within the black water lines. These are fitted to prevent the flush water (contaminated by black water) flowing the wrong direction during flushing activities.

17. The most important of these valves is fitted in the TMC Toilet/Black Tank Waste Line between the TMC Toilet macerator unit and the flush line connection point. This valve's function is to stop the flush water going back into the toilet bowl.

18. The second of these valves is installed in the Black Tank discharge line between the manual discharge take off point and the Waste Pump. This valve was deleted in late 2017. AOR has a modification on its update list that includes disabling this valve by removing the neoprene flap from inside the valve body.

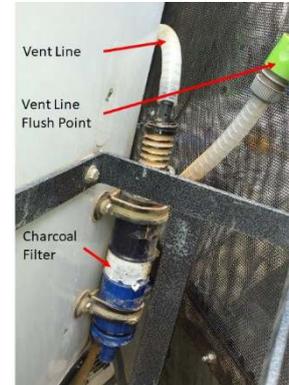
23. **Black Tank Vent Line.** The Black Tank Vent Line runs from the driver side of the black water tank forward and up the leading edge of the van immediately behind the stone guard on the inside of the 'jerry can' holder. It is normally hidden by a steel guard. The vent line is joined to the visual gauge line via a 'crossover join' just above the chassis rail. The gauge line leads to a removable plug/sealed flush point, and the vent line to an inverted 'U' turn, finishing in a charcoal filter that vents to the atmosphere. The joining of the gauge line to the vent line allows air in the gauge line to be displaced via the vent line and charcoal filter as the fluid level rises and falls in the gauge line.

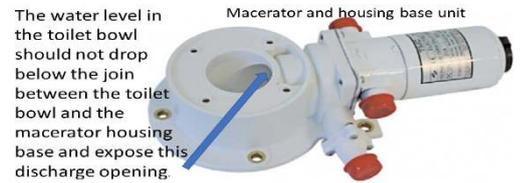
35. The picture to the right shows a typical anti syphon valve construction. The web site noted below provides a basic understanding of how the anti syphon works and why it is so important. <https://www.boatus.com/magazine/2018/april/anti-siphon-valves.asp>

34. **Anti Syphon Valve.** The anti syphon valve should not need programmed maintenance. If the standing water level in the toilet bowl after flushing drops below the join between the toilet bowl and the macerator housing (typically exposing the discharge pipe in the macerator housing), this could indicate that the anti syphon valve needs cleaning. As noted at paragraph 13 above, the anti-syphon valve is located at the rear of the shower cubical and is accessible by removing the drawers next to the shower. The valve itself is accessed by undoing the cap with the air vent hose attached, and then carefully removing the internal rubber 'Duckbill' valve. The valve can be cleaned using warm soapy water and a cotton bud.
